Work Order - Backup or Blockage Call

Hull Wastewater

Description: 26 Western Ave final blockage repair day

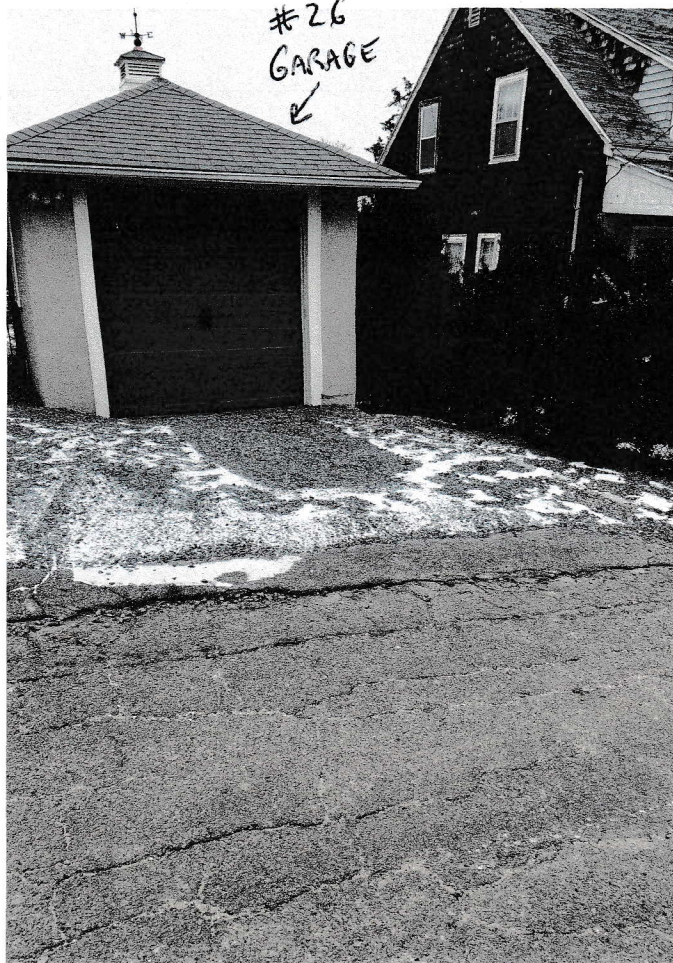
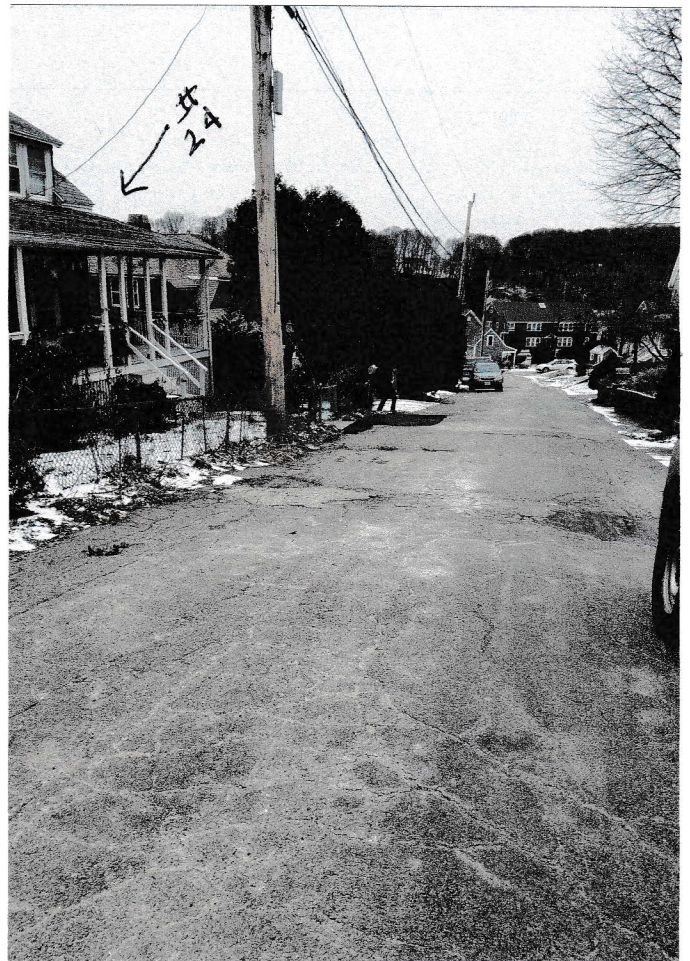
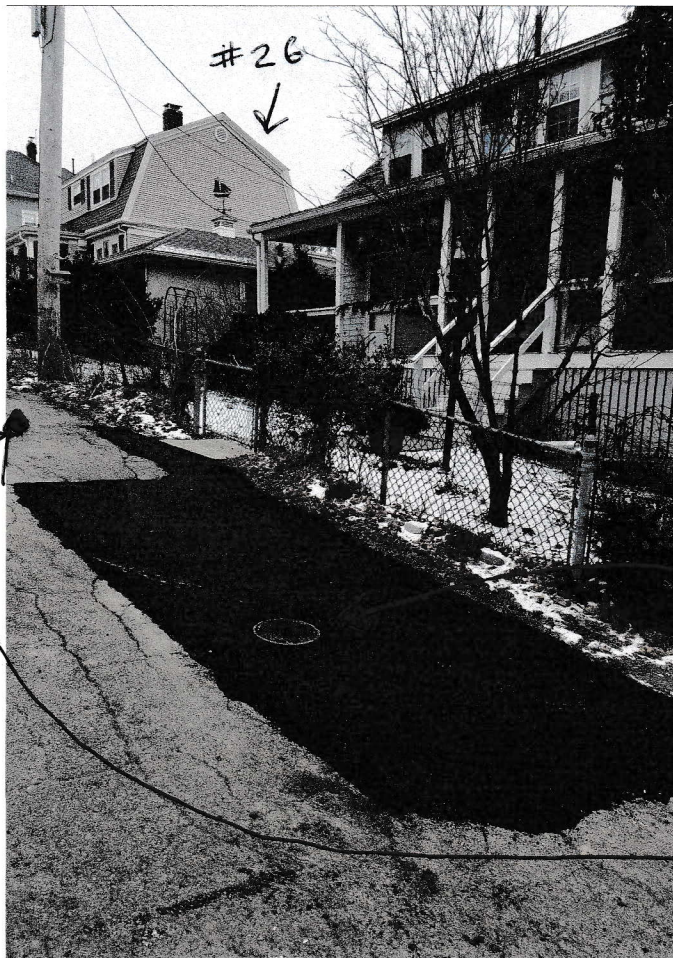
26 Western Ave Garage

NEW
CLEANOUT INSTALLED

Approx 18 ft up from cleanout
is where blockage found.

Service: Excavation downstream of #26 found blockage just upstream between house and excavation. Cleared line of grease and debris full blockage. Camera confirmed line was cleared + die tested. HUB installed cleanout port for better access to this area for preventive maintenance or camera.

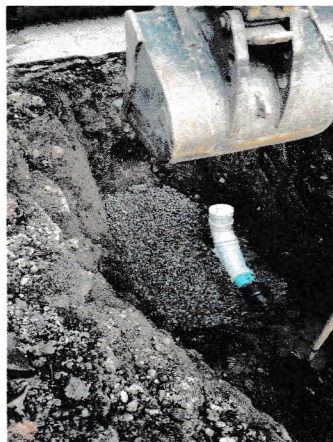
Cleanout facing upstream to grade

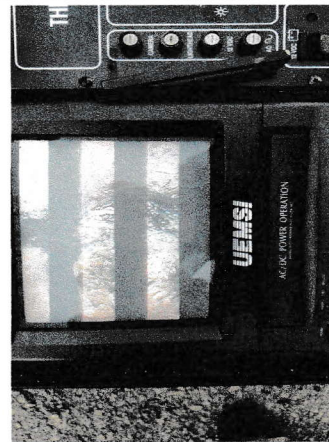
Blockage seen from camera
